30 August 2024

Structural Roof Inspection Report

Building 4123, 495 Festival Str, University of Pretoria.

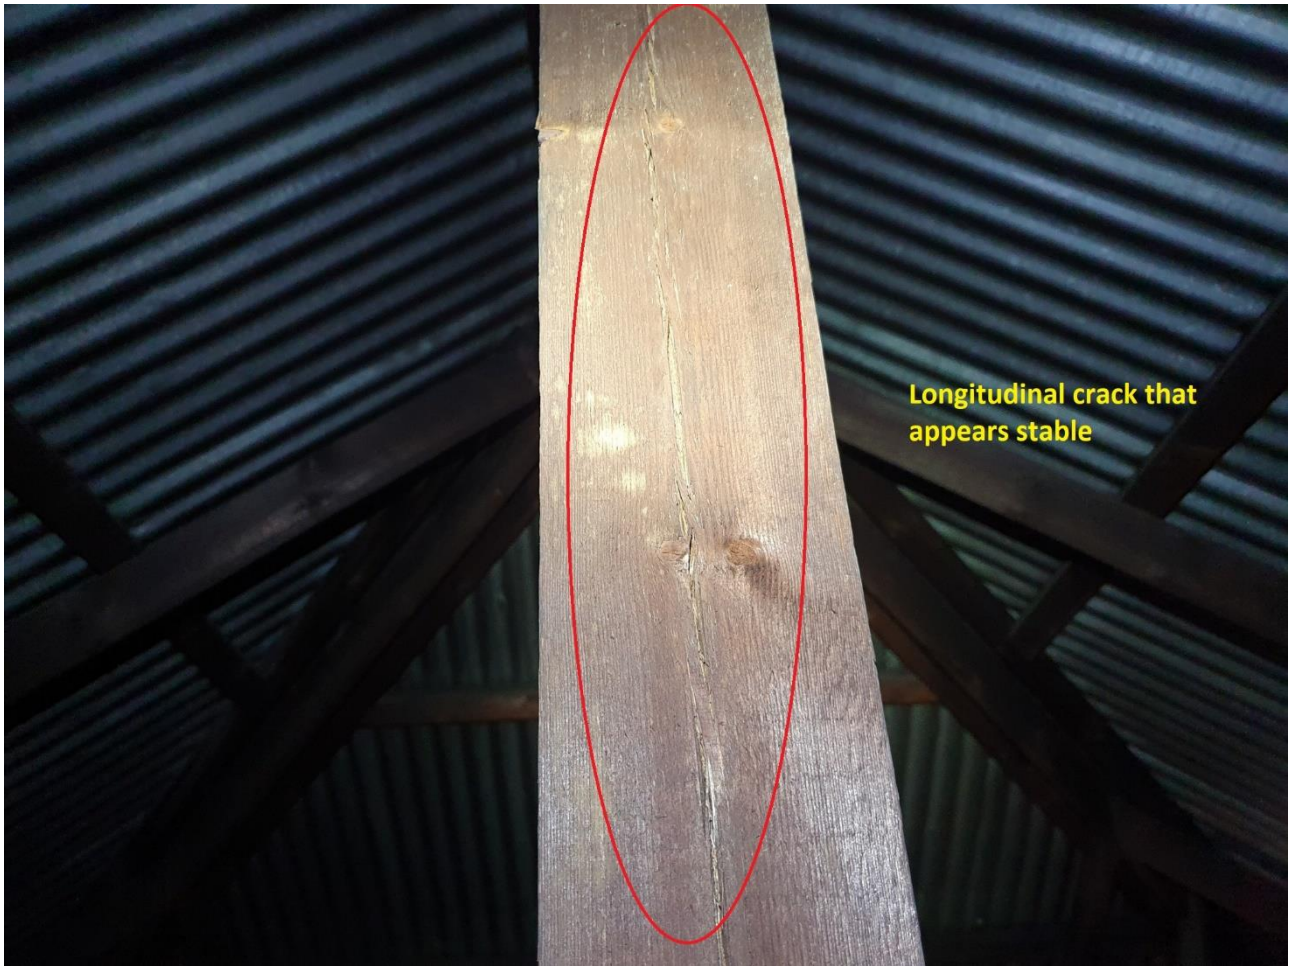
Longitudinal crack that appears stable

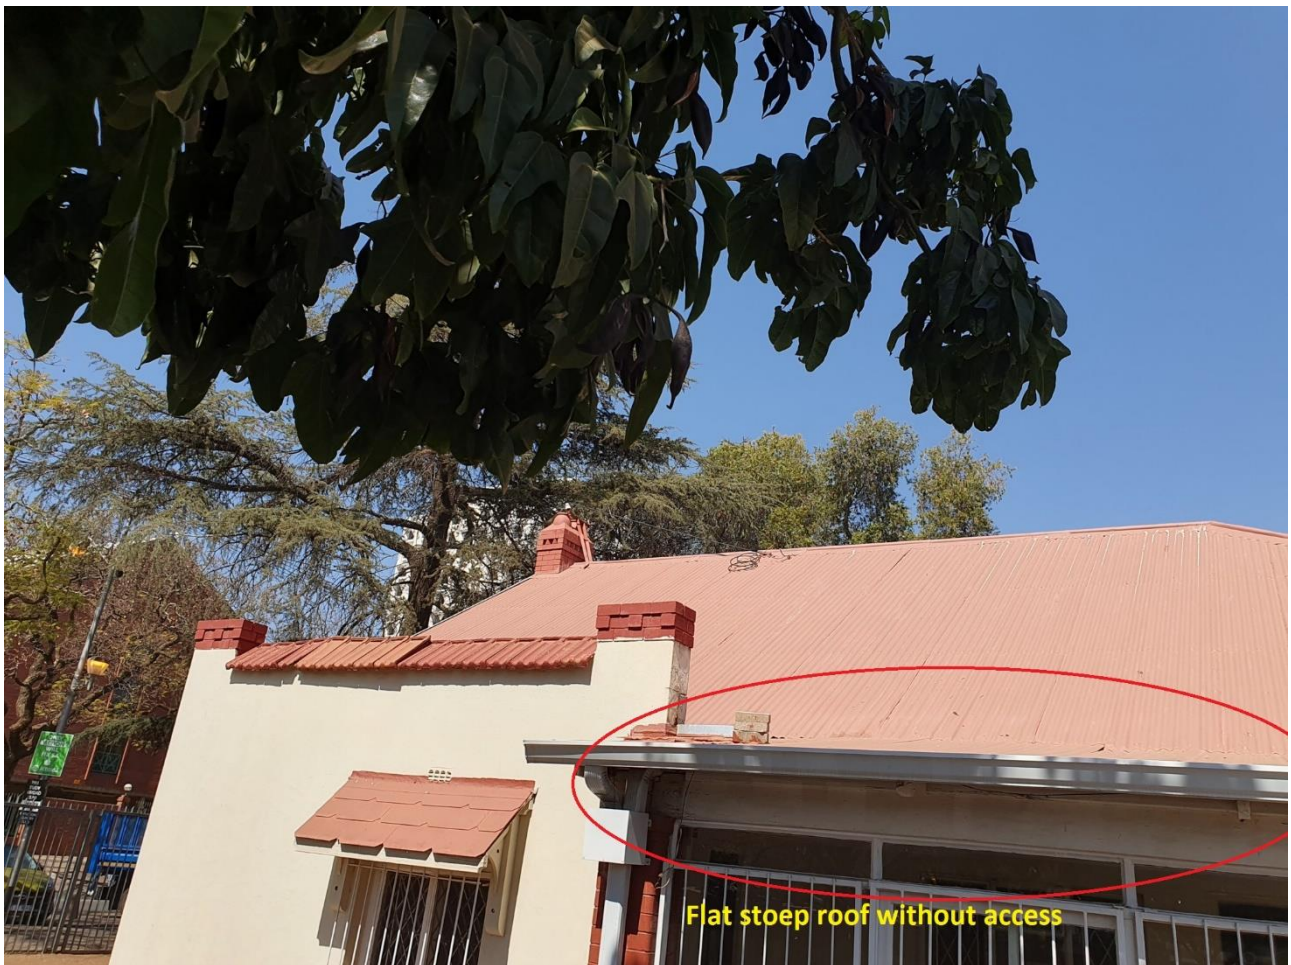
Flat stoep roof without access
