# Cracking the pigment code

During the production process of high-grade titania slag, the solidified tapped slag disintegrates. Prof Johan de Villiers and Alison Tuling investigated the problem to gain an understanding of the mechanism of the disintegration of the slag.

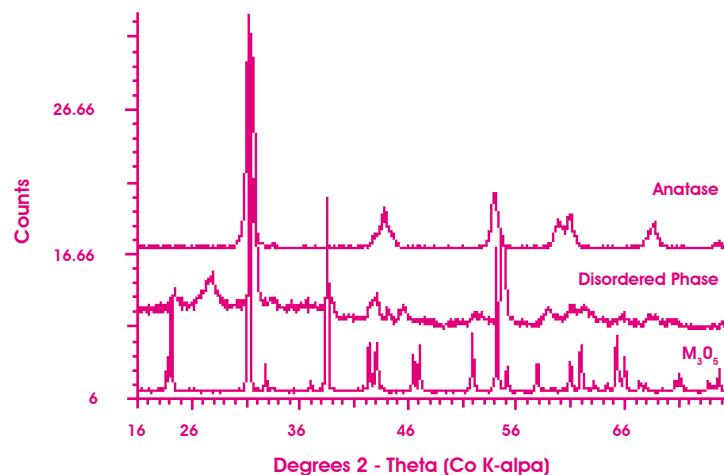
→ 1. Comparison of the XRD patterns of the oxidation product of titania slags with those of  $\text{M}_3\text{O}_5$  and anatase.

The predominant phase in commercial high-grade solidified titania slags is a compound with the pseudobrookite or  $\text{M}_3\text{O}_5$  structure (M refers to a combination of metallic elements in this oxide phase). Cooling of the slag in air results in rapid oxidation of the pseudobrookite phase. High-resolution transmission electron microscopy (TEM) and X-ray diffraction (XRD) techniques were

used to study the phase composition of the slag before and after oxidation. This investigation revealed that the precursor  $M_3O_5$  phase has an orthorhombic crystal structure, with a typical composition of  $(Fe_{0.27}Mg_{0.07}Al_{0.04}Ti^{3+}_{1.21}Ti^{4+}_{1.35})O_5$ . Oxidation of this slag during normal cooling appears to be associated with the formation of a new phase related to both  $M_3O_5$  and an anatase phase, as illustrated in Figure 1, where the strongest XRD peaks of all three phases are situated at similar angular positions. This oxidation product appears to be disordered in one crystallographic direction and has a composition corresponding to  $M_6O_{11}$ .

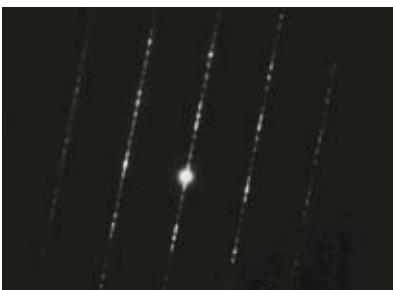
→ 3. High-resolution TEM micrograph of the disordered product.

Prof De Villiers and Alison Tuling discovered that the disorder in the oxidation product of the slag

varies, but well-ordered crystals could not be found. It is postulated that, depending on the composition (mainly the iron content), the proportions of  $M_3O_5$  and anatase in the intergrowth will vary, giving rise to disorder in the structure of the oxidised product.
