30 August 2024

Structural Roof Inspection Report

Building 4123, 495 Festival Str, University of Pretoria.

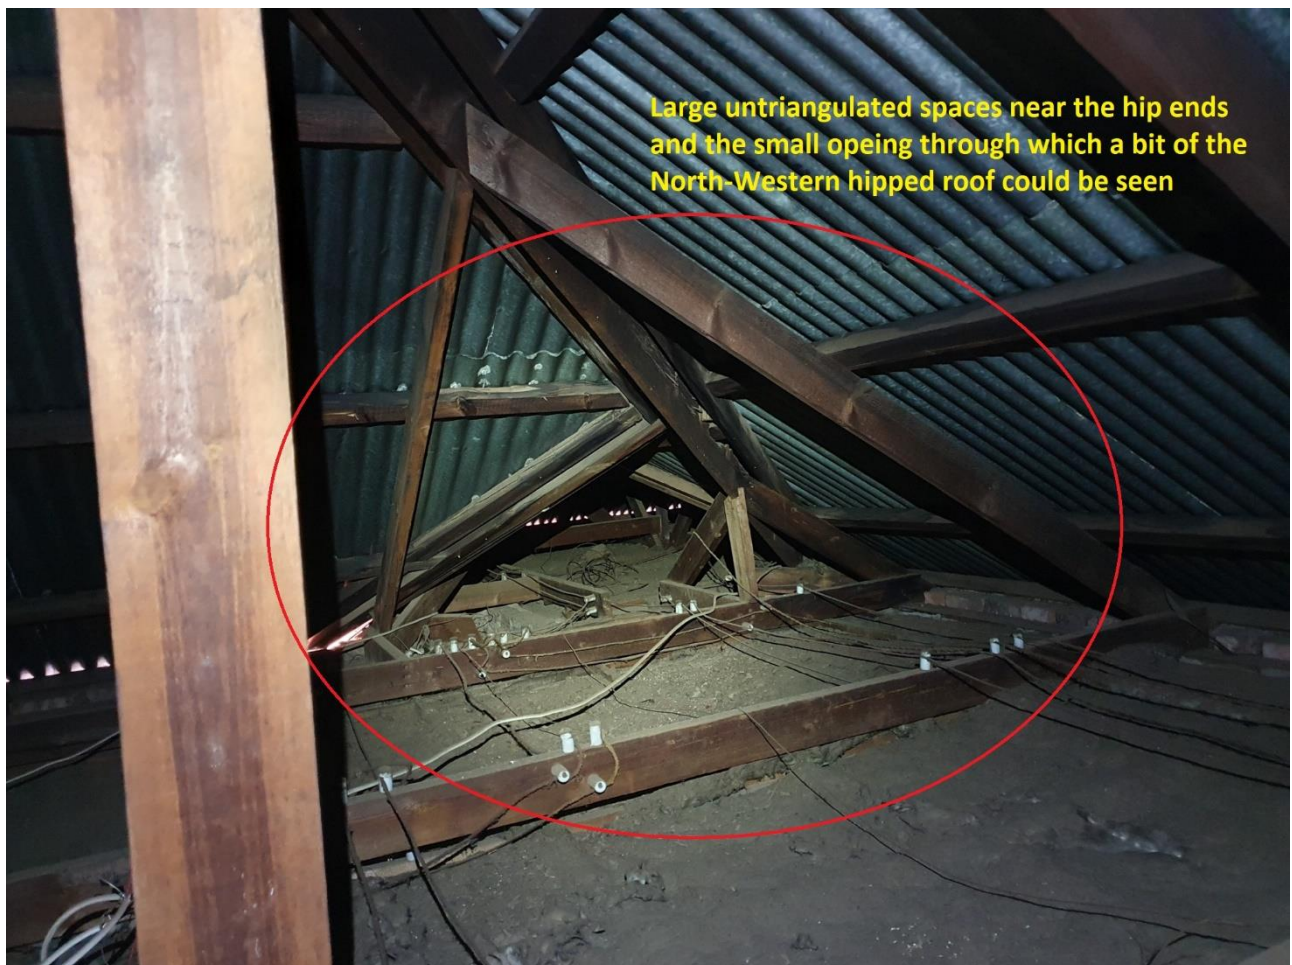
- None were indicated for demolition on the drawings received.
- Some longitudinal splits in truss members were found but appeared stable.
- Prof. Burdzik recommends not disturbing the roof with remedial works, but to monitor it at least annually (and preferably within 6 months, after the refurbishment) according to the OHS Act's Construction Regulations of 2014.

Longitudinal crack that appears stable
