## Structural Roof Inspection Report

Building 4124, 495 Festival Str, University of Pretoria.

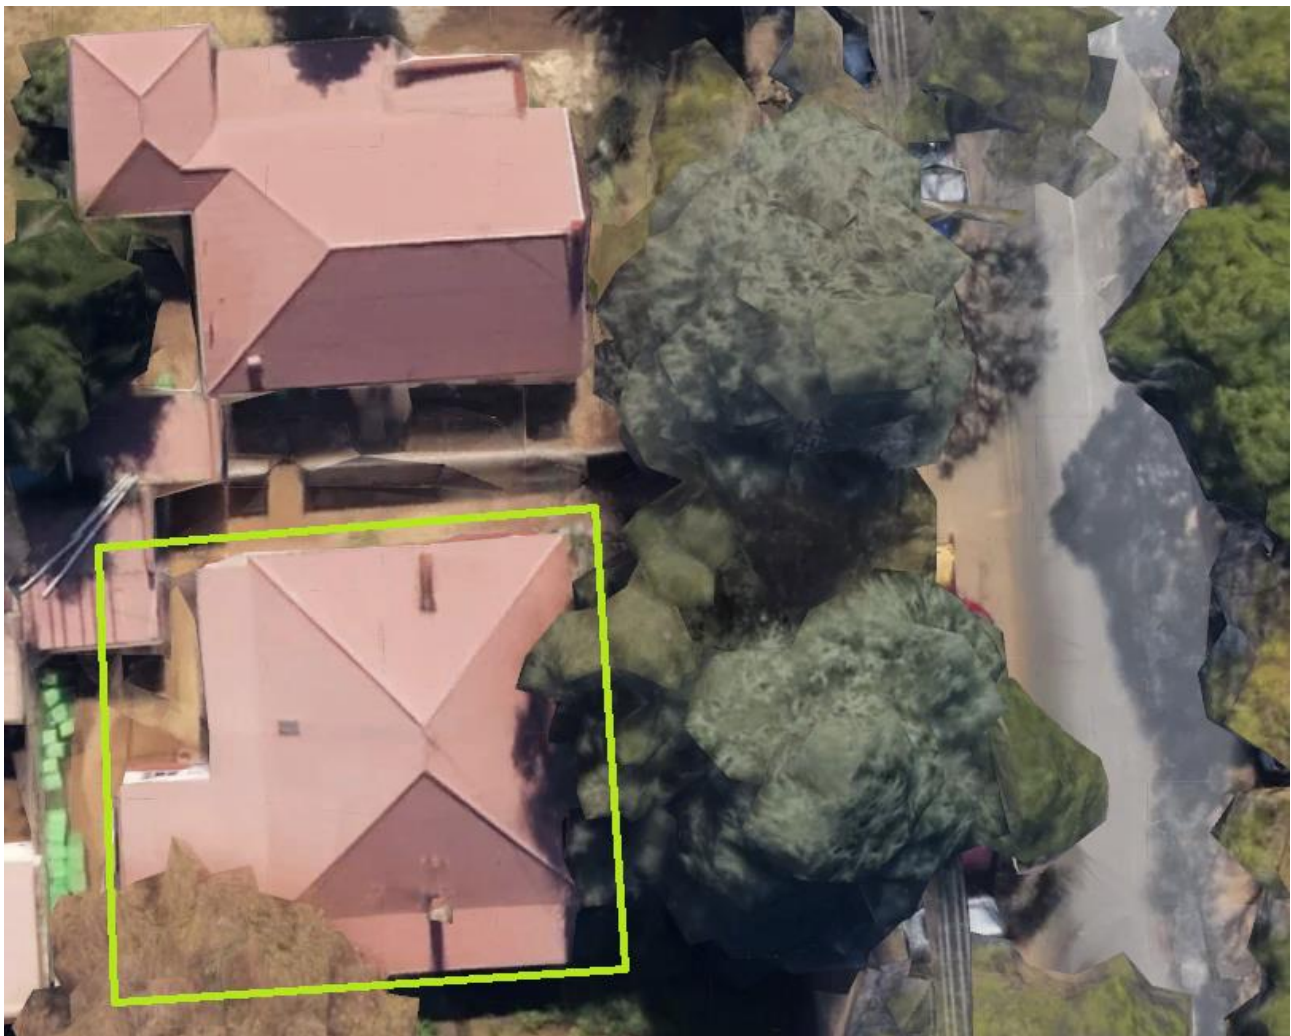
This report provides a summary of the observations that were made, following a visual inspection of the Timber Roof structure on 28 August 2024. The inspection was done from within and below the roof spaces in the general area marked in **green** above. No access was available in most short span rafter areas (sloped ceiling without trap door) but inspected where open like the garage. No part of this report may be copied or used without our prior written consent.
